Equipping of Kamurio borehole

Tirioko Ward, Akoret Division of East Pokot Sub-county in Baringo County.

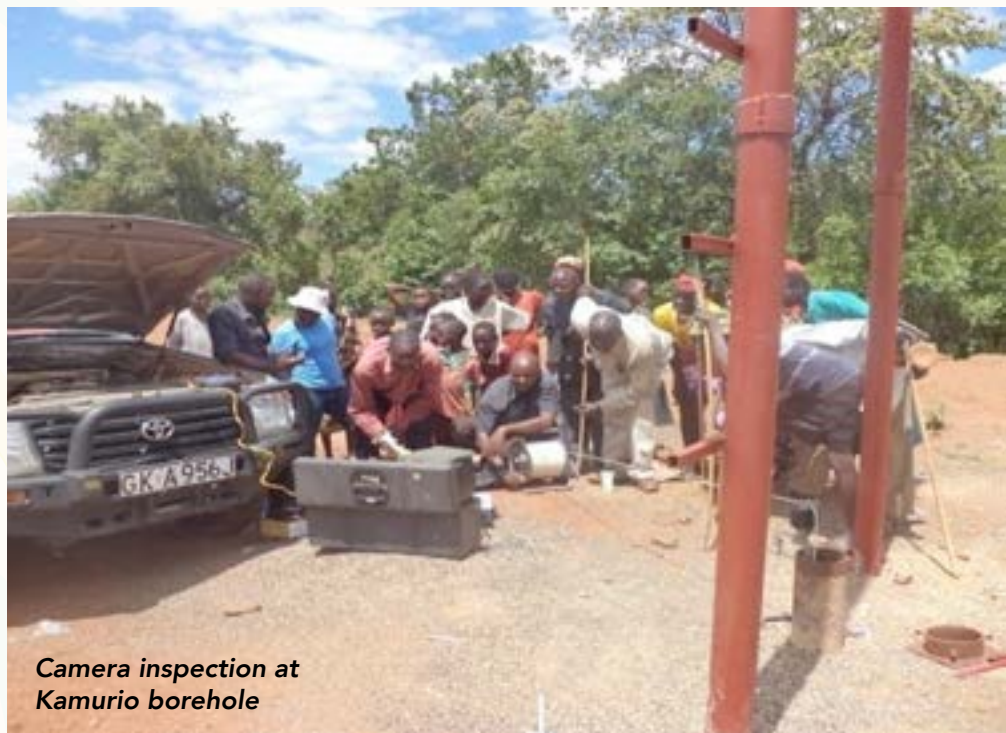
Camera inspection at Kamurio borehole

- Establishment of licensing and Environmental Impact Assessment status.
- Camera inspection of borehole to ascertain presence of permanent casing and screens.
- Test pumping for 24 hours, establishing a yield of approximately 3.6m³.
- Quality analysis of water, with results showing acceptable chemical and biological quality.
